# Manhole Inspection Summary

Manhole # S25KK\_006MH

**Location** Address: **2314 MORRIS ST**

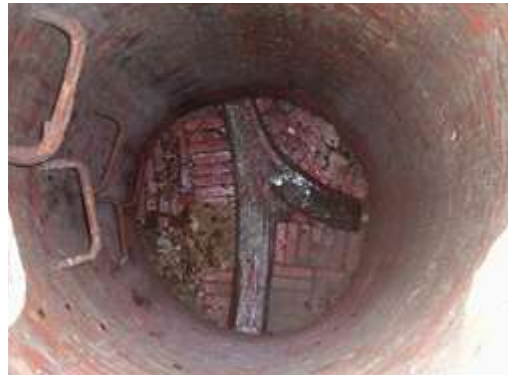
Top View

☐ Parged ☒ **Debris** (not Condition related)

☒ **Debris** (not Condition related)

**Steps** Count: **6** Missing: **0** ☒ **Corroded**

Corroded steps. Bench and Channel debris.

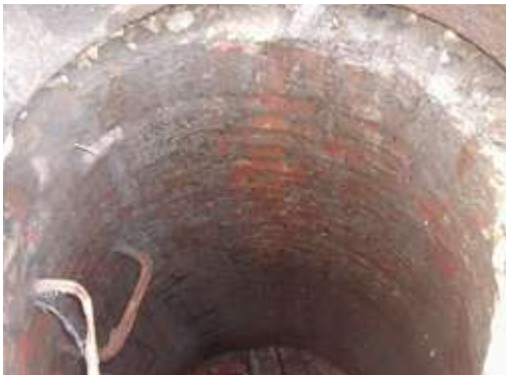
Defect

☒ **Leaks**

Infiltration: ☐ None ☒ **Joint** ☐ Cracks ☐ Mortar ☐ Roots ☐ Wall

Infiltration: ☐ None ☐ Joint ☐ Cracks ☐ Mortar ☐ Roots ☒ **Wall**

Frame leaks. Adjustment, Corbel and Barrel infiltration - other side.

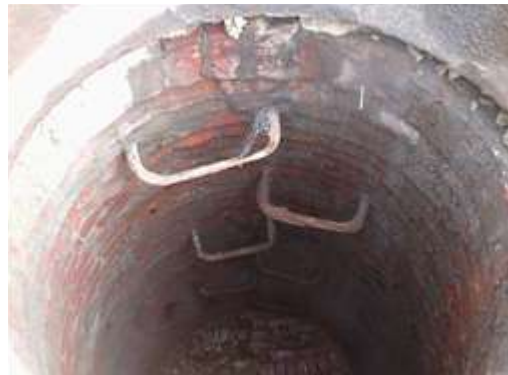
Defect

Frame leaks. Adjustment, Corbel and Barrel infiltration.

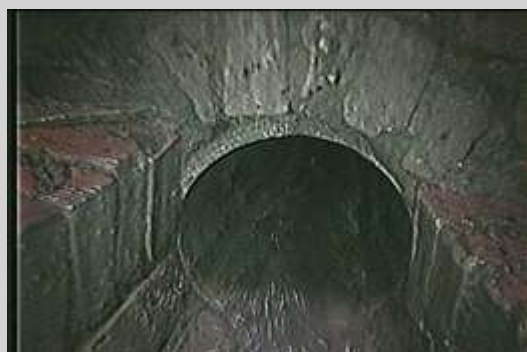
Pipe Out @ 12 O'Clock

Infiltration: **Evidence** Pipe Seal Cond: **Unknown**

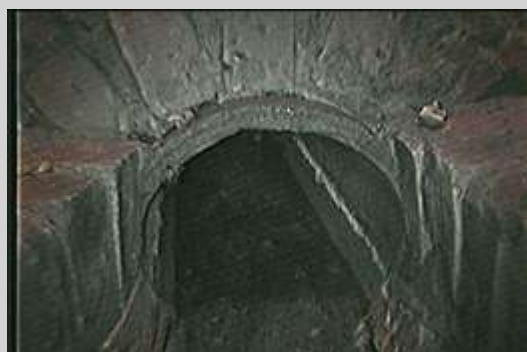
Pipe In @ 3 O'Clock

Deposits: ☐ None ☒ **Mud** ☐ Sludge ☒ **Debris** ☐ Grease

Silt Depth: **0.5** (in.) Deposits Extent: **Light**

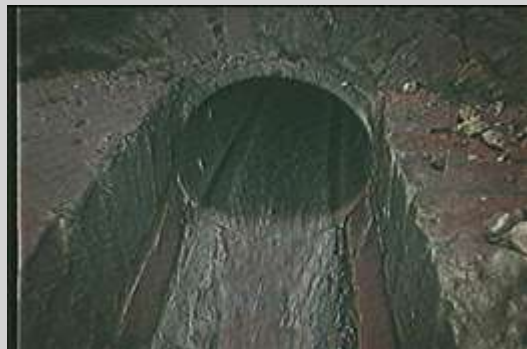
Pipe In @ 6 O'Clock

Condition: ☐ Sound ☐ Cracked ☐ Root Intrusion ☒ **Deteriorated** ☐ Leaks ☐ Debris

Channel deterioration.

Infiltration: **Evidence**

Pipe Seal Cond: **Cracked**
